Sound Level Monitoring Report

Monitored by	Patrick Kelly P.Eng Meridian Brick Canada Ltd
Location	East Quarry, Westhaven Dr, opp pedestrian access (see photo below) 30 paces from fence line, height 1.5 m
Date	Monday March 18, 2019 to Tuesday March 19, 2019
Weather	Temp high 4C low -3 C, wind 8 – 20 km/h NW, cloudy & sunny, snow dusting
Quarry activity	Shale extraction Centre Quarry, dozer, loader, trucks.
Construction activity	None
Settings	Duration – 60 min, Calibration – 94 dB, Input range – Low,
Settings	Freq Weight – dBA, SPL – Slow, FFT - Full
Limits - pt reception	Shale extraction; LAeq < 50 dBA, Construction; LAeq < 60 dBA, LAmx < 65 dBA

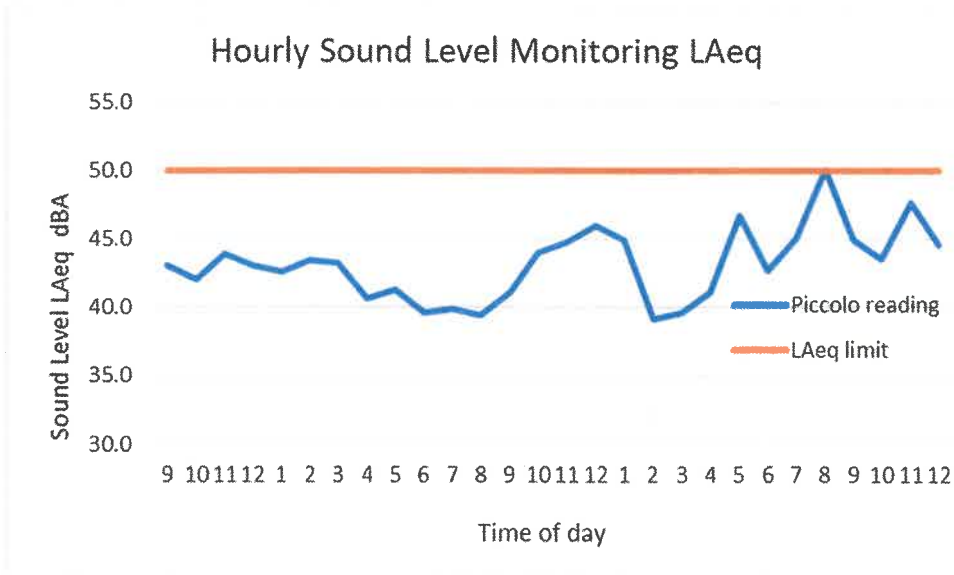
#	Start Date	Start Time	End Time	Duration	LAeq
129	3/18/2019	9:00:02 AM	10:00:00 AM	0:59:58	43.1
130	3/18/2019	10:00:02 AM	11:00:00 AM	0:59:58	42.0
131	3/18/2019	11:00:02 AM	12:00:00 PM	0:59:58	43.9
132	3/18/2019	12:00:02 PM	1:00:00 PM	0:59:58	43.1
133	3/18/2019	1:00:02 PM	2:00:00 PM	0:59:58	42.6
134	3/18/2019	2:00:02 PM	3:00:00 PM	0:59:58	43.4
135	3/18/2019	3:00:02 PM	4:00:00 PM	0:59:58	43.2
136	3/18/2019	4:00:02 PM	5:00:00 PM	0:59:58	40.6
137	3/18/2019	5:00:02 PM	6:00:00 PM	0:59:58	41.3
138	3/18/2019	6:00:02 PM	7:00:00 PM	0:59:58	39.6
139	3/18/2019	7:00:02 PM	8:00:00 PM	0:59:58	39.9
140	3/18/2019	8:00:02 PM	9:00:00 PM	0:59:58	39.4

141	3/18/2019	9:00:02 PM	10:00:00 PM	0:59:58	41.1
142	3/18/2019	10:00:02 PM	11:00:00 PM	0:59:58	44.0
143	3/18/2019	11:00:02 PM	12:00:00 AM	0:59:58	44.7
144	3/19/2019	12:00:02 AM	1:00:00 AM	0:59:58	46.0
145	3/19/2019	1:00:02 AM	2:00:00 AM	0:59:58	44.9
146	3/19/2019	2:00:02 AM	3:00:00 AM	0:59:58	39.1
147	3/19/2019	3:00:02 AM	4:00:00 AM	0:59:58	39.6
148	3/19/2019	4:00:02 AM	5:00:00 AM	0:59:58	41.1
149	3/19/2019	5:00:02 AM	6:00:00 AM	0:59:58	46.7
150	3/19/2019	6:00:02 AM	7:00:00 AM	0:59:58	42.7
151	3/19/2019	7:00:02 AM	8:00:00 AM	0:59:58	45.0
152	3/19/2019	8:00:02 AM	9:00:00 AM	0:59:58	50.1
153	3/19/2019	9:00:02 AM	10:00:00 AM	0:59:58	44.9
154	3/19/2019	10:00:02 AM	11:00:00 AM	0:59:58	43.5
155	3/19/2019	11:00:02 AM	12:00:00 PM	0:59:58	47.6
156	3/19/2019	12:00:02 PM	1:00:00 PM	0:59:58	44.6

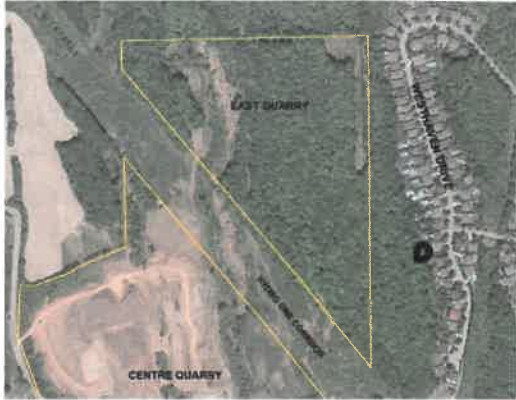
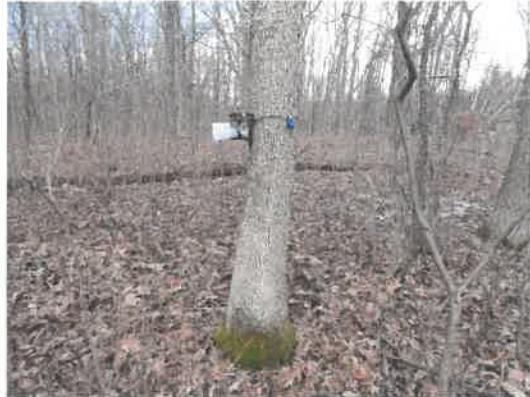
Location of monitoring station (black inked) and photo of Piccolo set up
